SPEERS RUN DAM
NDI Pa - 505 .

PHASE I INSPECTION REPORT,
NATIONAL DAM INSPECTION PROGRAM. ✓

Speers Run Dam

PHASE I INSPECTION REPORT
NATIONAL DAM INSPECTION PROGRAM
SPEERS RUN DAM
NDI# PA-505, PENNDER# 63-6

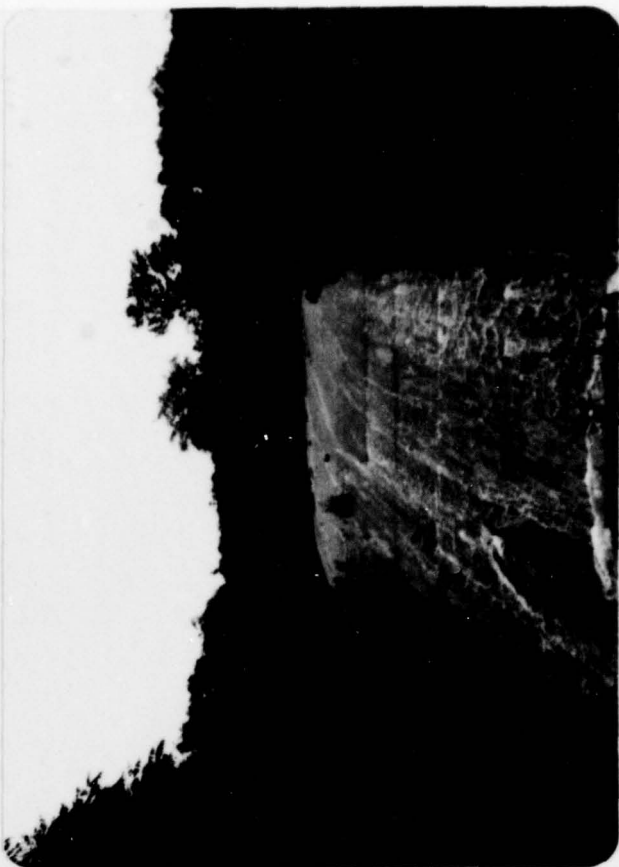
b. Appurtenant Structures. Based on the visual inspection, the spillway appeared to be in good condition with only some minor scaling visible.

PHOTOGRAPH 4 View of the upstream portion of the
Speers Run spillway. Note the ogee-
crested weir in the background of the
photograph.

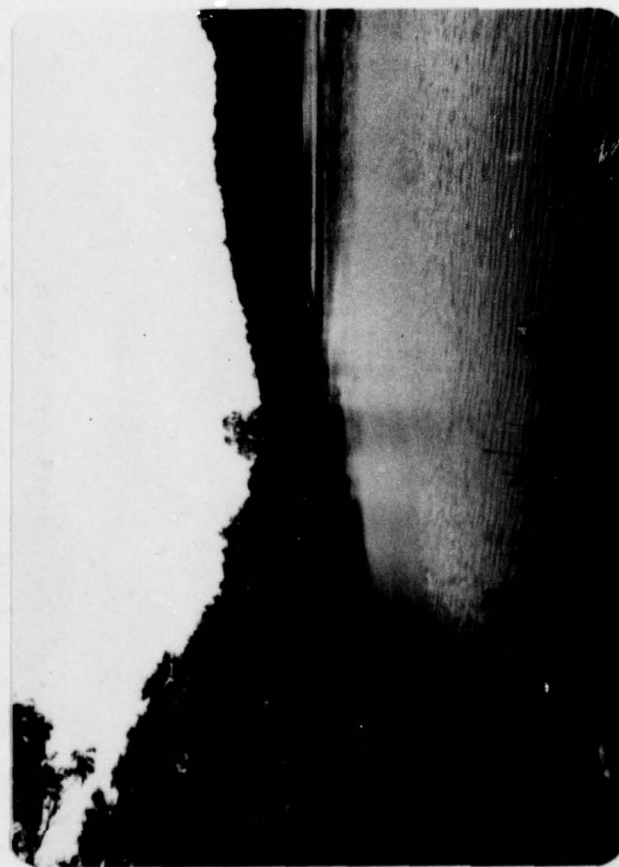
PHOTOGRAPH 3 View of the upstream portion of the
Speers Run embankment taken from the
left abutment.

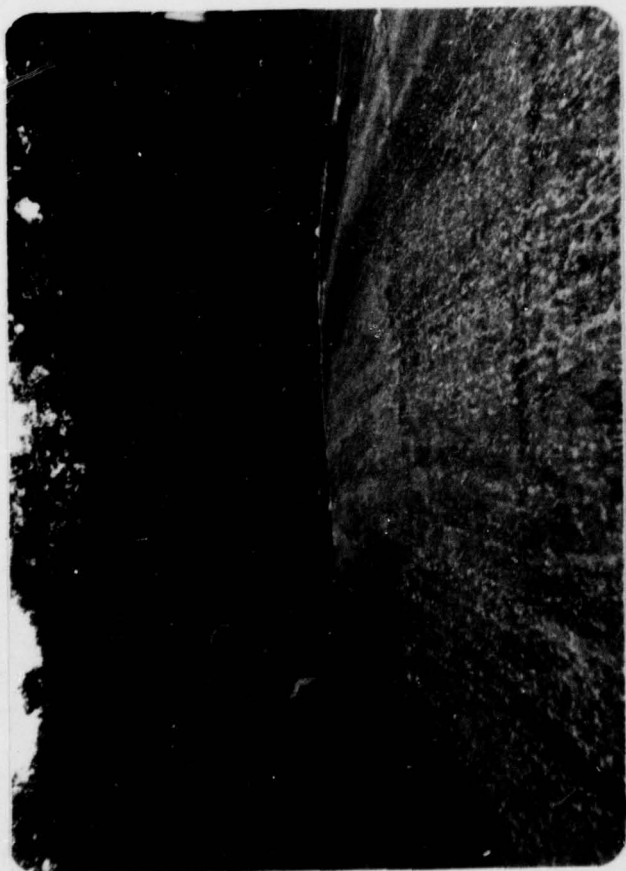
1. Spillway. The spillway, spillway abutments, apron and plunge pool all appeared to be in good condition. Some minor cracking and spalling of the concrete was observed and most of the construction joints were bitumen filled.

PHOTOGRAPH 5 View of the downstream portion of the Speers Run spillway. Spillway overflow discharges into the plunge pool at the center of the photograph before re-entering the natural downstream drainage.

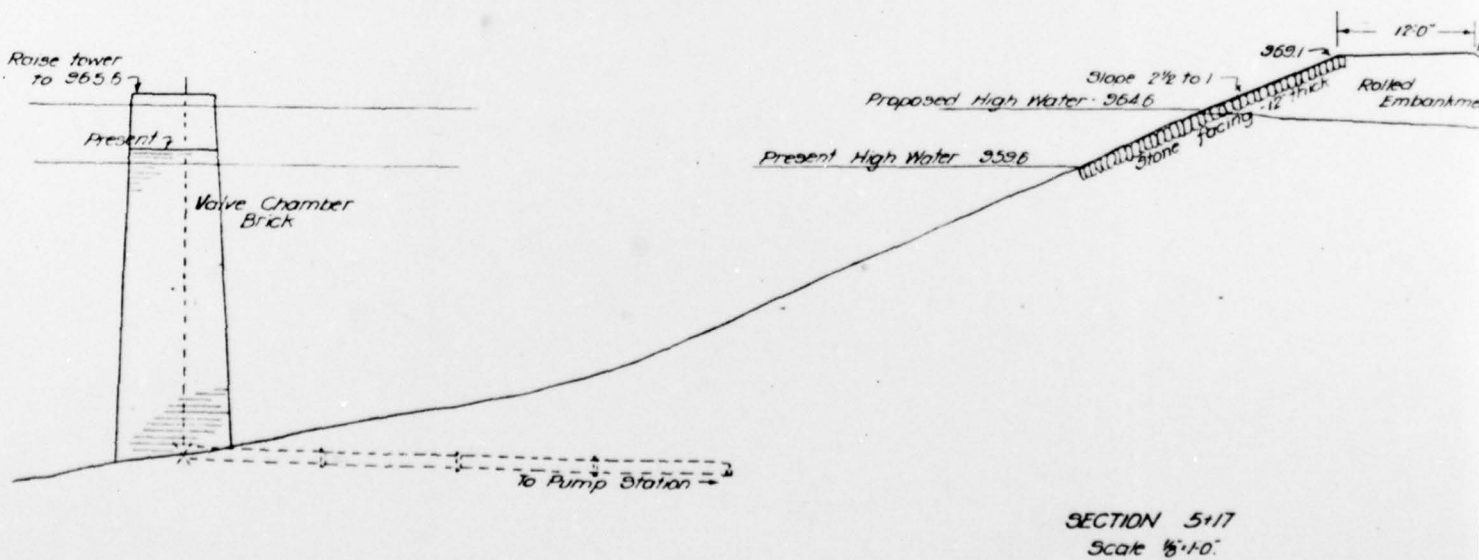
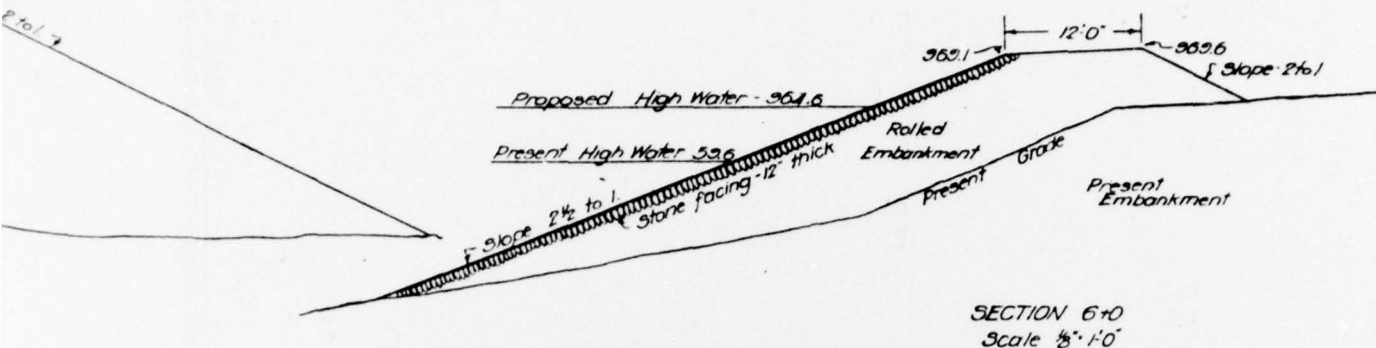
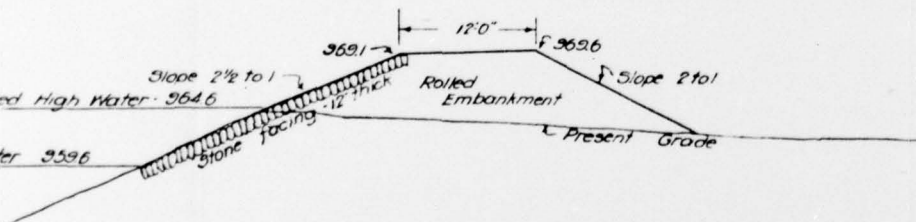
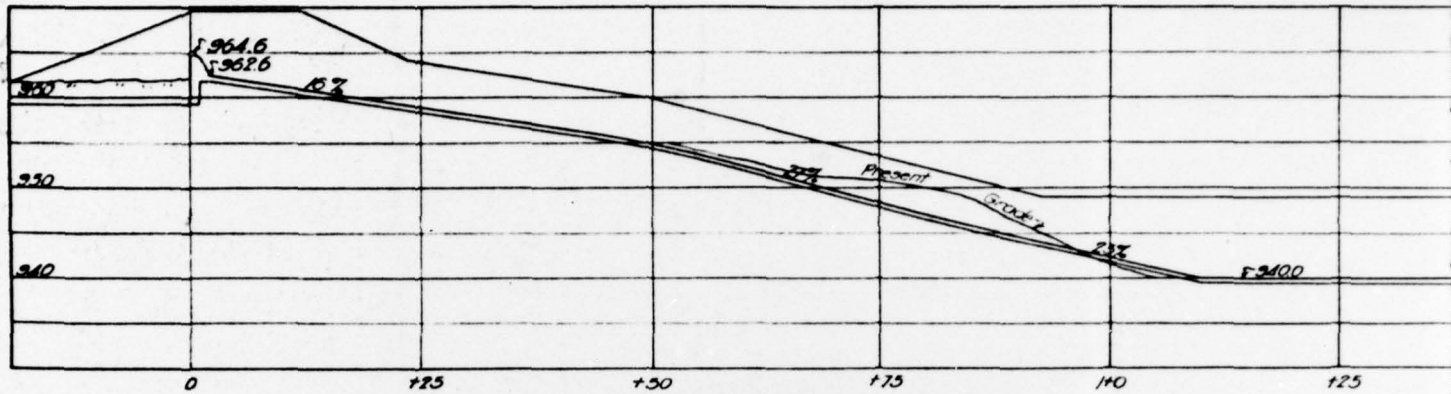
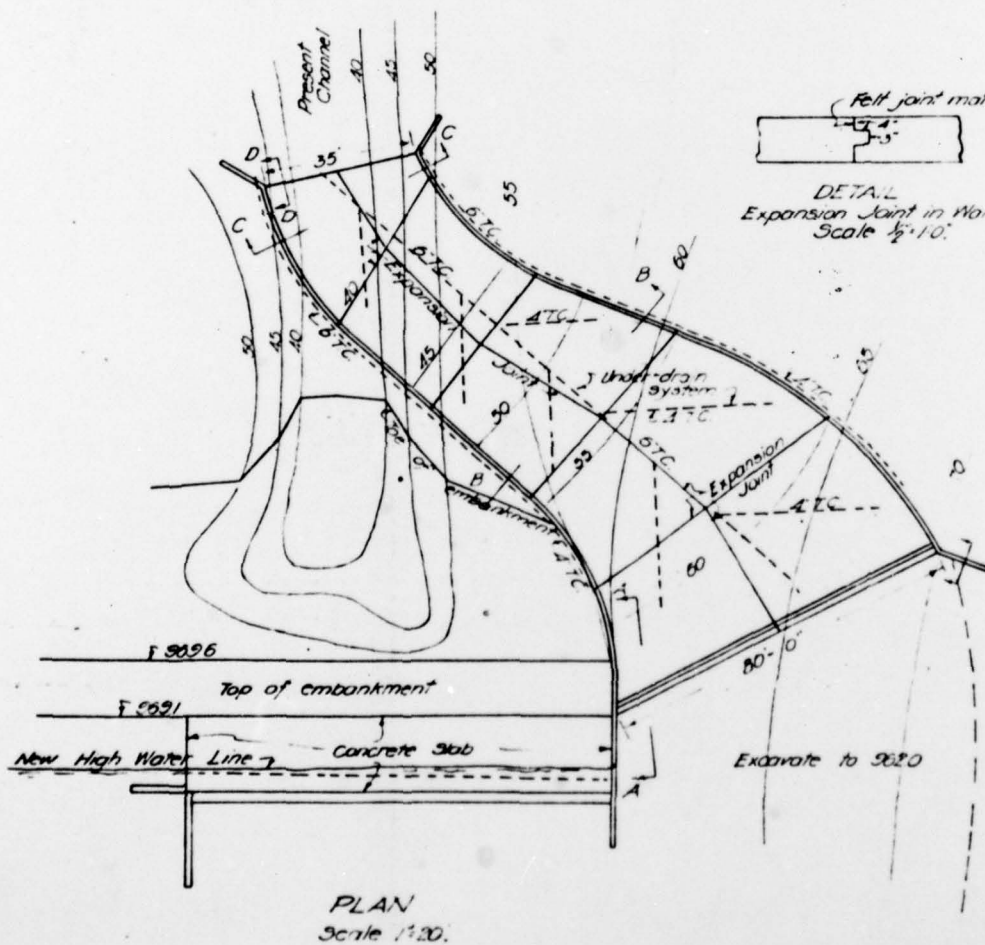
FIGURE 3

Type - One 24-inch blow-off line and one 18-inch
supply pipe originate at intake (brick valve chamber) as
indicated on Figure 3. Chamber submerged at time of inspec-
tion.

The intake structure shown on Figure 3 is submerged and cannot be inspected at the present reservoir level. Outlet appurtenances could not be located and as such pose a potentially hazardous condition, since they are under full hydraulic head beneath the embankment and apparently cannot be closed.

a. The owner enlist the services of a registered professional engineer to inspect and assess the condition of the intake and outlet works and perform those remedial measures deemed necessary to restore their operability including closing the outlet works at their intake ends.
